## A House For All Seasons: The Five Mile House

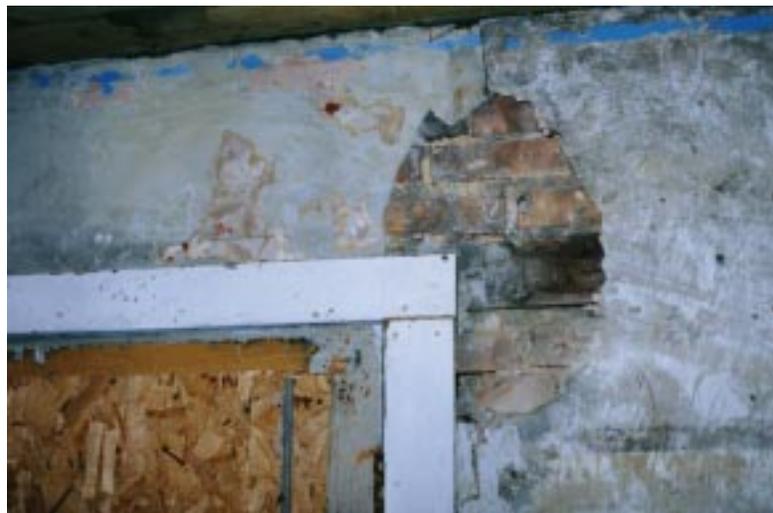
Deteriorated and chipped plaster over the doors and windows on the north and south walls reveals hewn wooden lintels. Rather than having individual lintels, a single 4 1/4 inch high lintel on each wall stretches more than 9 ½ feet over each door and window combination (Fig. 3). The

**Fig. 3. A single hand-hewn lintel stretches across each door and window combination in the east room addition.**

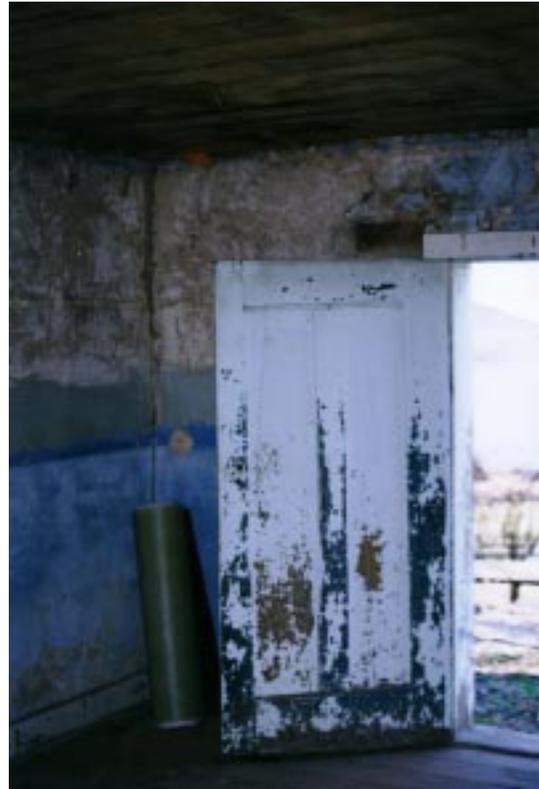
**Fig. 4. This blue and tan two-panel door probably is original to the east room addition of the house.**

inch door has flaking white paint over blue paint on the door's stiles and rails and tan paint on the inset panels (Fig. 4). The door, which is attached with two hinges, probably survived because it was protected from the weather by the added kitchen ell. Also, because the door was an inside door when the house's other exterior doors were replaced in the late 19<sup>th</sup> or early 20<sup>th</sup> centuries, there was little aesthetic reason to upgrade it at the same time.

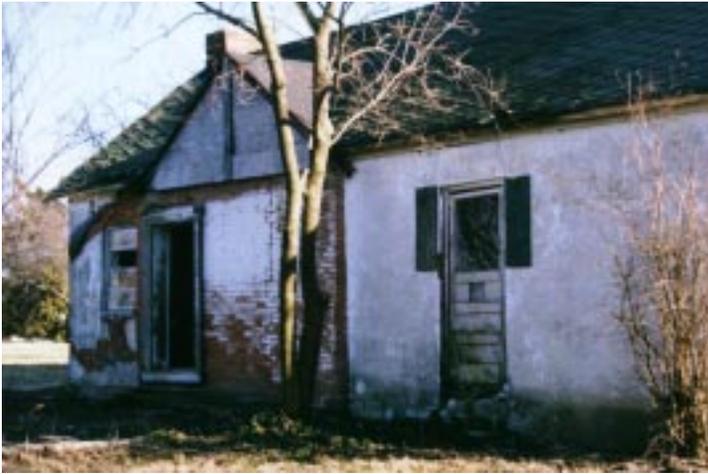
**Fig. 5. The north side of the house still shows plenty of evidence of the removed kitchen ell.**

gable roof remains attached a little below the ridge of the main part of the structure; however, the ell's roof was truncated at the edge of the brick building (and the resulting opening boarded up) when the ell was removed (Fig. 5).

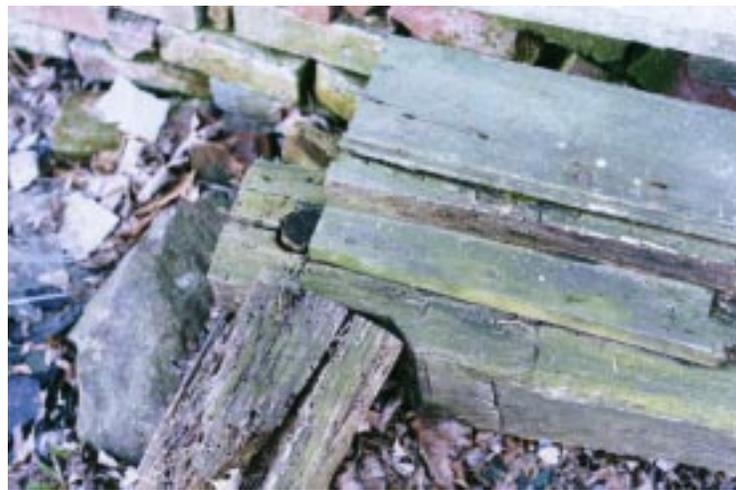
The size of the remaining timbers suggests the addition used braced frame construction techniques. The remaining sills on the north and south sides are 7 inches wide and six inches deep. The remaining sill on the east side is 6 inches square. The ell remnants include a partial loose concrete block foundation with hand-hewn wooden sills still in place on the north, east, and south sides. The remaining sills were horizontally half-lapped at the ell's corners and secured with wooden pegs, also known as treenails (Fig. 6). Square nails remain in the sills and in a couple of remaining floor beams. The floor

**Fig. 6. The remains of the kitchen ell include these wonderfully joined pieces of the old sills.**

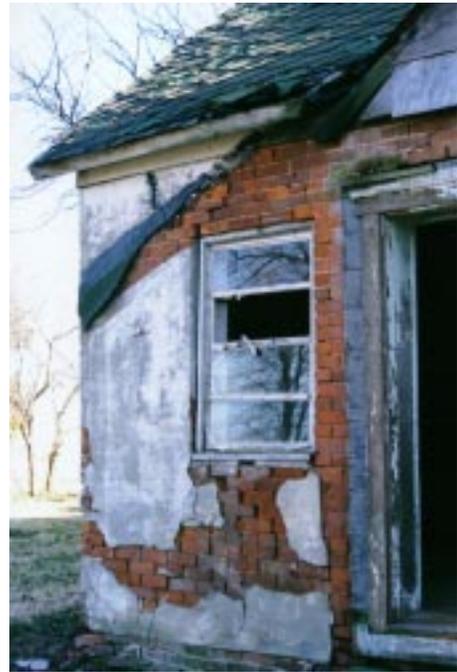
A roof slope outlined with tar and shingle paper on the side of the brick addition on the east side of the kitchen ell is evidence of a covered porch in the corner formed between the rooms. The porch probably was unenclosed because, unlike in the kitchen ell, the east room's exterior brick wall is stuccoed over in the porch area (Fig.

**Fig. 7. The shingle paper tarred above the window on the northeast corner of the house is evidence of a kitchen ell porch.**

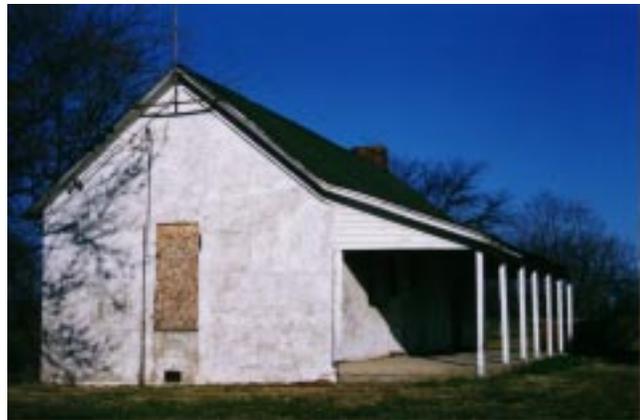
round nails became available in about 1880. The seven porch posts across the front of the porch have been replaced with modern lumber, but the two 3 ½ inch square posts closest to the house are original to the porch and sport decorative chamfered corners (Fig. 8). The porch has a decorative concrete block foundation and currently has a poured-in-place concrete slab floor. The porch also has hooks screwed in the ceiling to support a porch swing.

**Fig. 8. The Five Mile House has a full-width porch on its front (south) side**

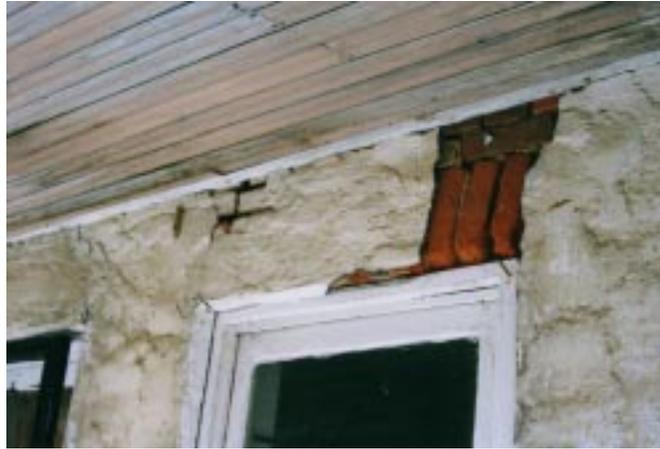
**Fig. 9. Fallen stucco reveals a decorative flat brick arch over the south window in the east room addition.**

house with mirror image doors and windows on each side. Another impressive architectural feature is the flat brick arch over the front window in the east addition (Fig. 9). This is purely a decorative feature, as the structural element supporting the wall above the 45 by 29 ½ inch window opening is a hewn wooden beam mentioned earlier in the interior east room description. The window opening at the rear of the brick addition is 44 ½ by 29 inches and does not have a flat brick arch. Unfortunately, the windows in the original room of the house are well stuccoed over, concealing the presence (or lack of presence) of flat brick arches. The window on the south side of the west room is 45 ½ by 28 ½ inches. The window on the west side of the older room is boarded up, preventing an accurate measurement from the interior.

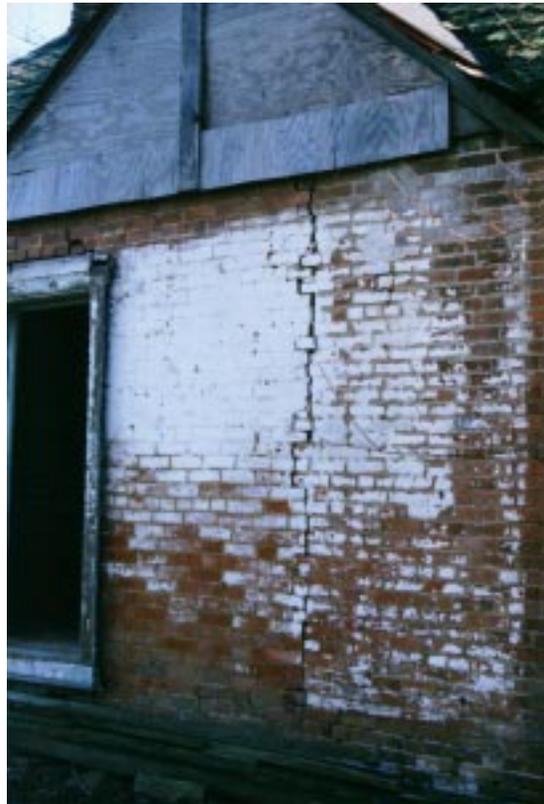
location of the interior wall, it is apparent that the joint is at the east side of the interior wall. This shows that the interior wall originally was an exterior wall for the west room and that the east room was added later (Fig.10). This section of wall also offers some other interesting construction details. The bricks in the old and new sections are of slightly different sizes. Although all of the bricks are quite irregular, the bricks in the original structure measure about 8 ½ by 2 inches while the bricks in the newer addition measure about 8 1/8 by 2 ¼ inches. And, although both rooms use forms of the American Bond pattern, the older section has five rows of stretchers between rows of headers while the newer section has anywhere from five to seven rows of stretchers between rows of headers.

**Fig. 10. This crack shows where the east room was added on to the original one-room brick house. The wall was not stuccoed here because it was protected by the kitchen ell.**
