# Tracking Large Woody Debris in a Low-Energy Meandering River

## Embarras River, Illinois

Jessica N. Intravaia & James D. Riley  
Department of Geology/Geography, Eastern Illinois University

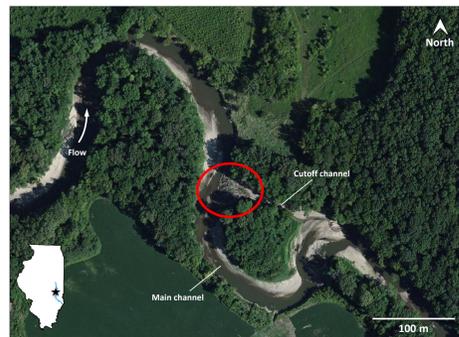
Figure 1. Aerial photo of the study site. The red oval indicates the position of the LWD. Star on inset map shows the location of the LWD on the Embarras River in east central Illinois.

The field site for the research is located at the entrance of a meander bend chute cutoff on the Embarras River, approximately 5 km south of Charleston, Illinois (Figure 1). The Embarras River is a low-gradient tributary of the Wabash River. The field site lies within the Shelbyville Morainic System, a terminal moraine deposited during the Wisconsin Glacial Episode, and drains 2,308 km<sup>2</sup> of till plains that are today used predominantly for agriculture. LWD has accumulated at the downstream corner of the entrance of the cutoff channel and extends across much of it, covering approximately 850 m<sup>2</sup>. The current LWD pile began to develop in 2007, although historical aerial photographs and comments from a long-term landowner indicate past occurrences of LWD breakup and accumulation at this location.
