# Spatiotemporal dynamics of a chute cutoff on the Embarras River, Illinois

Abigail L. Knight & James D. Riley  
Department of Geology/Geography, Eastern Illinois University

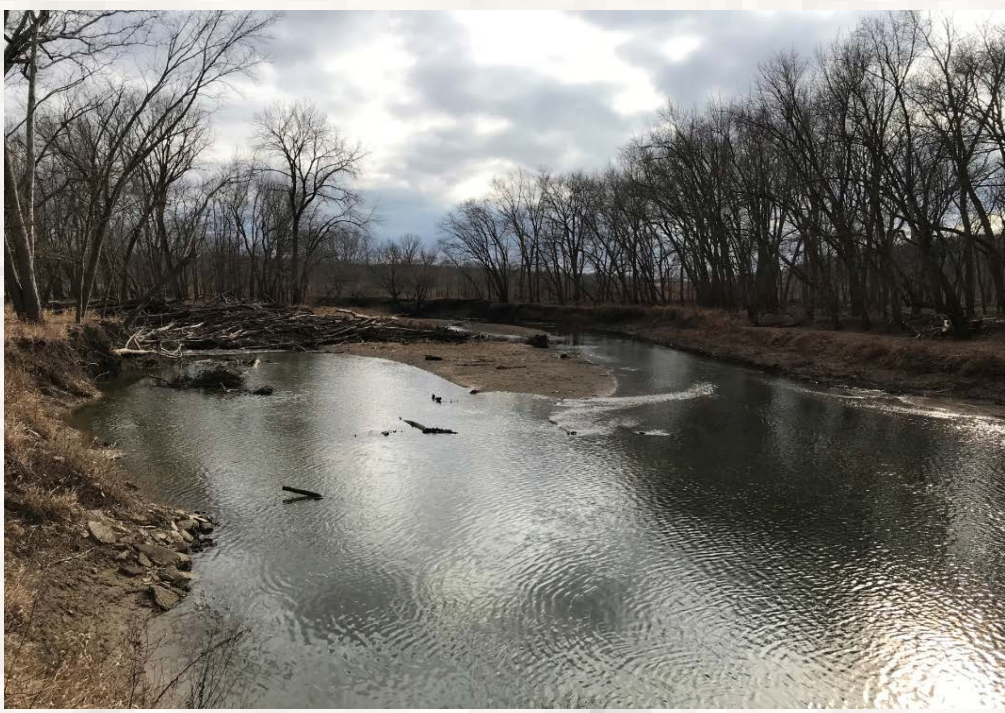
**Figure 2.** Channel of investigation; chute cutoff (left) and main channel (right). Photo taken facing downstream February 16, 2018.

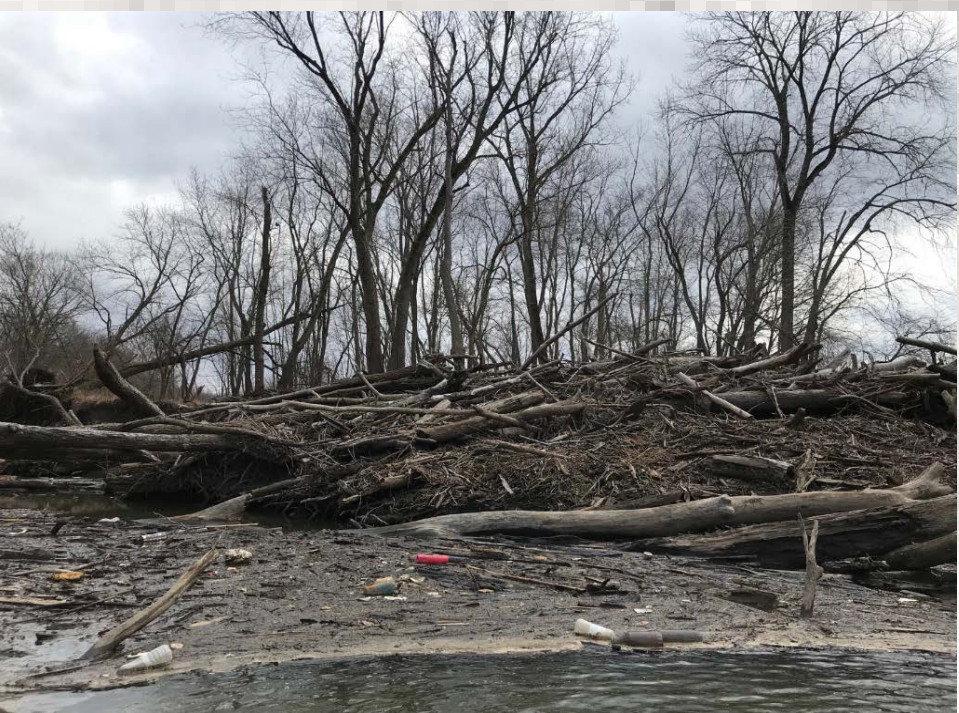
**Figure 3.** Close-up of large woody debris pile. Photo taken February 16, 2018.

The study site (Figure 1) is a compound meander loop on the Embarras River, a tributary of the Wabash River, located 5 km south of Charleston, Illinois. The site is situated within a terminal moraine complex deposited during the glacial retreat of the Wisconsin Glacial Episode. The low-gradient river drains 2,308 km<sup>2</sup> of till plains upstream of the site (StreamStats). Channel width is 35 m upstream of the bend and narrows to 30 m downstream. There is a chute cutoff (Figure 2) across the point bar that has failed to capture the main flow for many years. A bar separates flow between the main and cutoff channels on which large woody debris can accumulate (Figure 3). Bed sediments at this site range from muddy clay to coarse gravel.

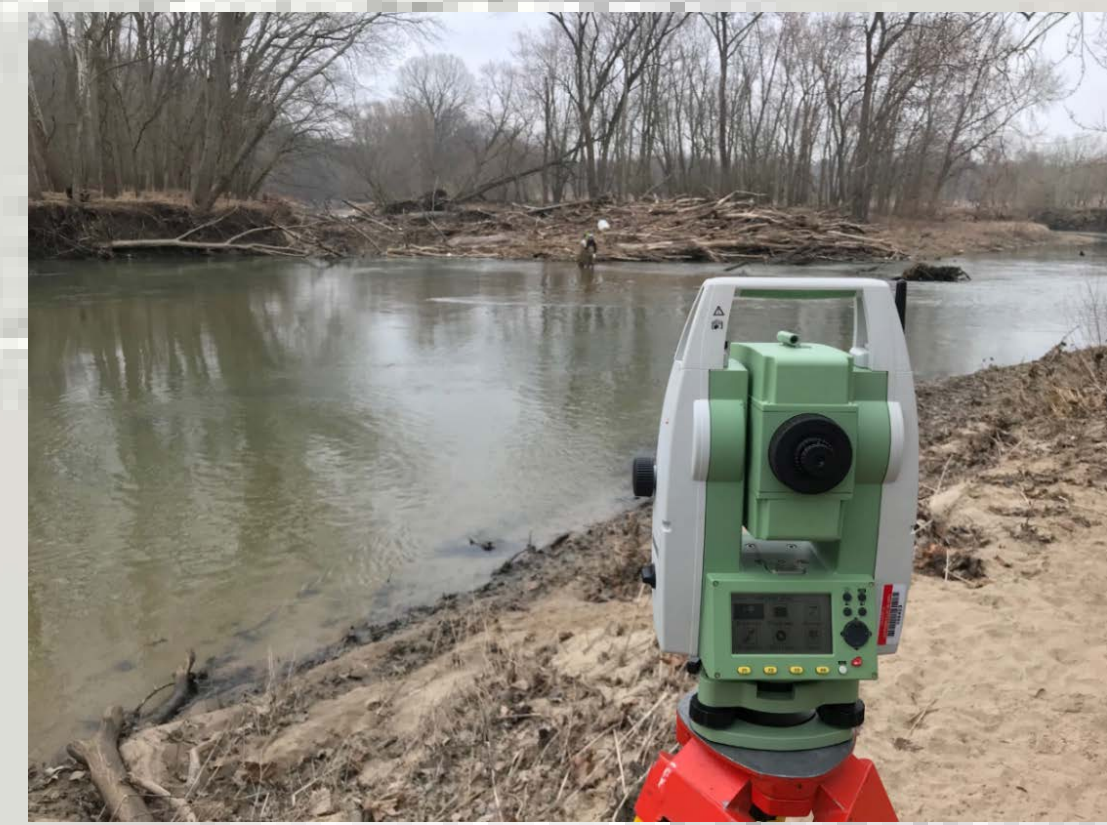
**Figure 4.** Survey of the site using the TS02 total station. Photo taken on March 12, 2018.

The study site was surveyed with a Leica TS02 manual total station (Figure 4). This method employed electro-optical scanning from a reference point with known x, y, and z coordinates at a target located a known height above the bed to find coordinates at that location. The site was surveyed on February 16, and twice again on March 12 and June 7 following high flow events using the same equipment and methods to collect hundreds of data points both in the channel and on the banks. Three maps of channel bathymetry were created by spatially interpolating the elevation data using the kriging method in ESRI ArcGIS.

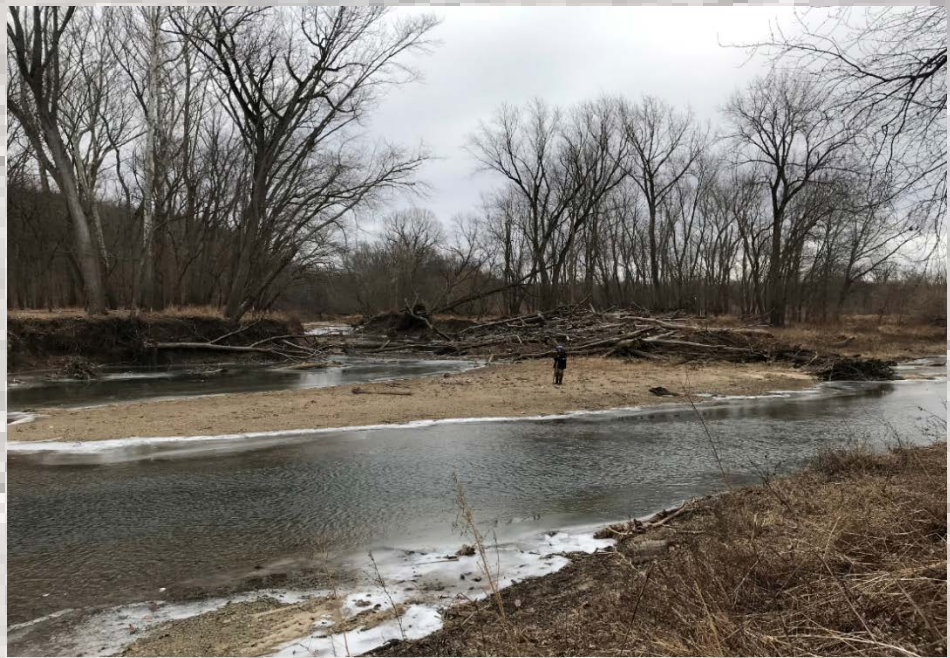
**Figure 10.** Exposure of a gravel bar upstream of the woody debris pile. Photo taken February 3, 2018.

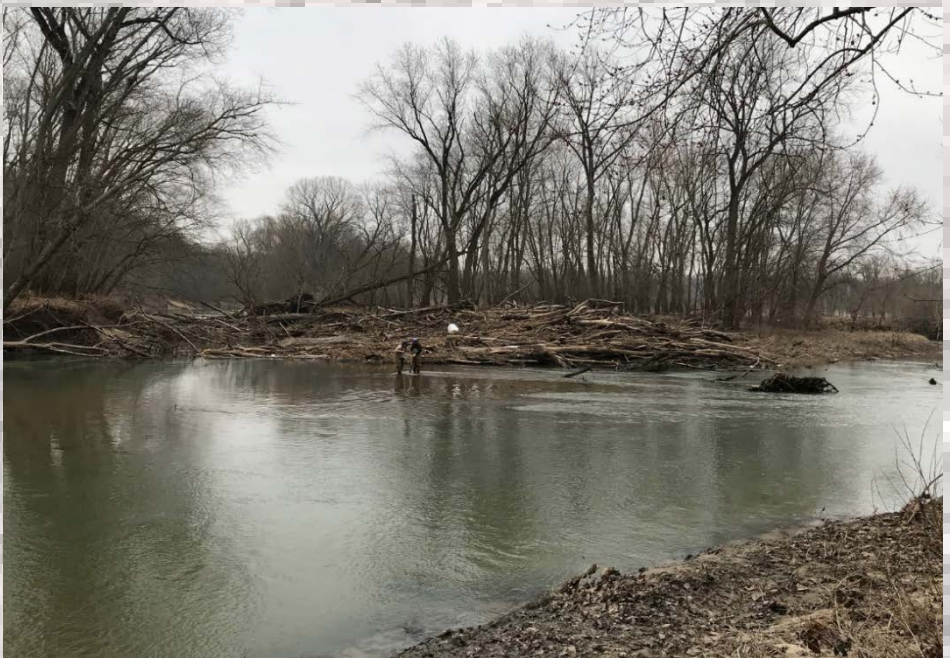
**Figure 11.** Gravel bar fully submerged. Photo taken March 12, 2018.
