Daniel H. Stadler & James D. Riley
Department of Geology/Geography, Eastern Illinois University

INTRODUCTION

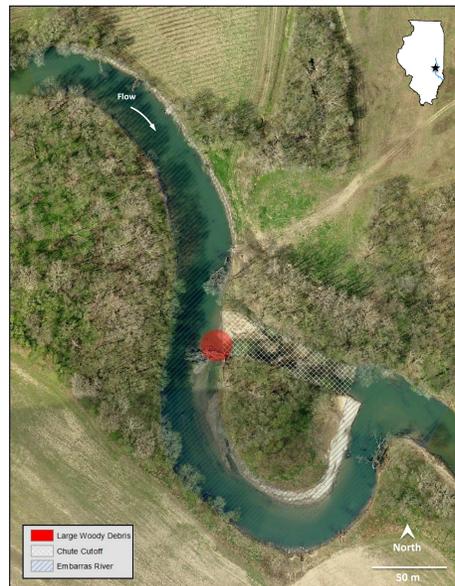
Figure 1. Aerial photo of the study site taken in spring 2007. An accumulation of large woody debris has since collected at the head of the small island between the cutoff and main channels. Star on inset map shows the location of this bend and chute cutoff on the Embarras River in east central Illinois.

The field site is a 0.65 km reach of the Embarras River, a tributary of the Wabash River, consisting of a compound meander loop and a chute cutoff (Figure 1). At the site, the low-gradient naturally meandering river drains 2,308 km² of mostly till plains. Many of the upstream tributaries and portions the main channel itself have been straightened and channelized for the purpose of agricultural drainage (Urban, 2002). LWD has accumulated at the downstream corner of the entrance of the cutoff channel and partially obstructs it (Figure 2). Woody debris usually enters the river as a result of bank failures caused by lateral erosion along the forested river corridor. Water flows through both channels, although most of the flow continues through the meander bend.

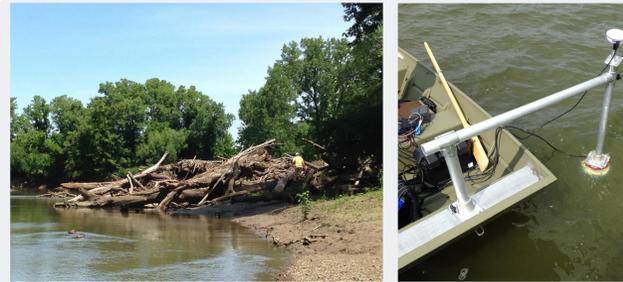
Figure 2 (left). Photograph of a portion of the LWD accumulation taken downstream on the main channel during summer 2014. Note the person for scale. Figure 3 (right). Data collection equipment mounted to the jon boat, including ADCP and differential GPS antenna.

3D velocity components and depth data were collected on March 19, 2015 with a 1200 kHz Workhorse Rio Grande acoustic Doppler current profiler (ADCP) affixed to a mount on a small jon boat (Figure 3). The Doppler shift between acoustic pulses transmitted by the ADCP and backscatter from suspended particles and the channel bed was used to resolve velocity components and water depth. A Hemisphere A100 differential global positioning system (GPS) captured boat position and velocity. The Velocity Mapping Toolbox (Parsons et al., 2013) was used to post-process ADCP data. Depth measurements were collected longitudinally and converted to elevations based on water stage data. ESRI

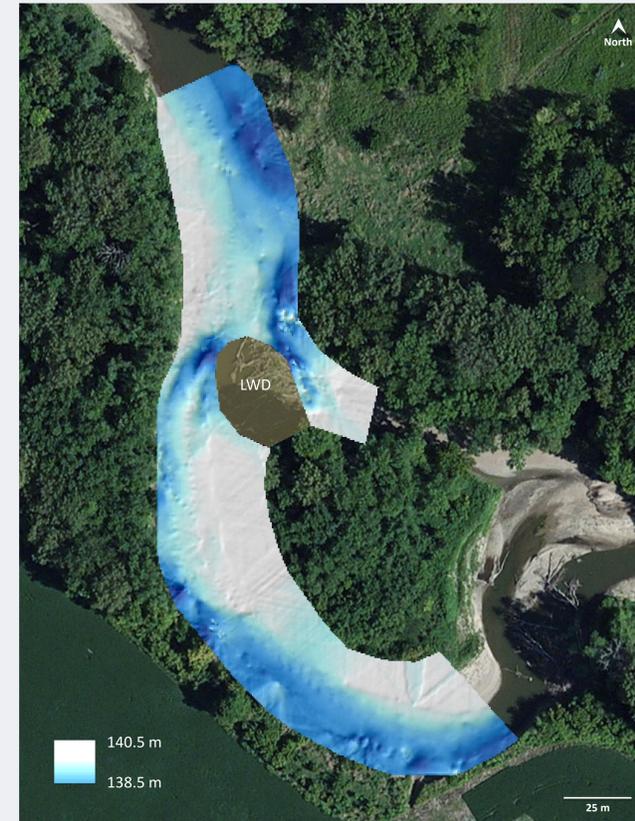
Figure 5. Bed topography of portions of the meander loop and chute cutoff, March 19, 2015. Elevation above sea level in meters.

The bed morphology of the meander loop conforms with patterns typically found in bends (Figure 5). The entrance to the chute cutoff is located near the inflection point between bends. The pool positioned against the outer bank of the main channel in the upstream bend extends toward a region of bed scour at the upper end of the cutoff channel. Flow entering this channel is confined to a narrow zone between the LWD and the north bank of the channel resulting in scouring of the bed and bank erosion (Figure 6). The cutoff channel rapidly shallows downstream from the LWD, where coarse gravel and even cobbles are deposited on the bed.

A pronounced scour hole is also found in the main channel adjacent to the LWD. Flow likely accelerates as it is pinned between the LWD and the west bank. The LWD protects a broad point bar immediately downstream that extends across most of the channel cross section. Farther downstream, a wide pool underlies an actively eroding cut bank where the bend has elongated (Figure 7).

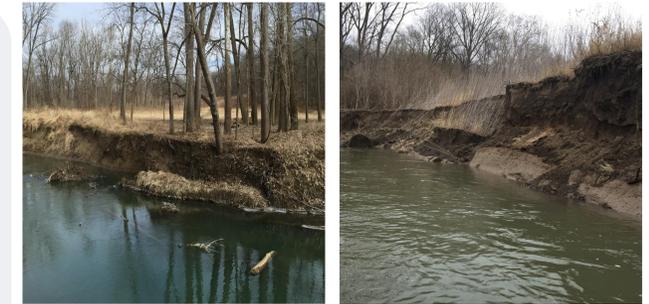
Figure 6 (left). Bank failure at the upstream corner of the entrance to the chute cutoff. Figure 7 (right). Bank erosion along the cut bank at the downstream end of the main channel.
