## A House For All Seasons: The Five Mile House

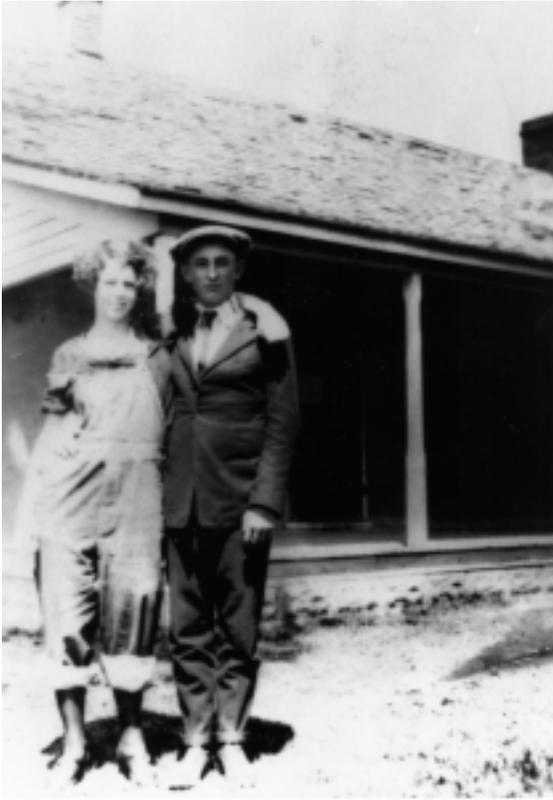
**Fig. 2. A small chimney is visible rising out of the middle of the west room above the couple in this early 20<sup>th</sup> century photograph.**

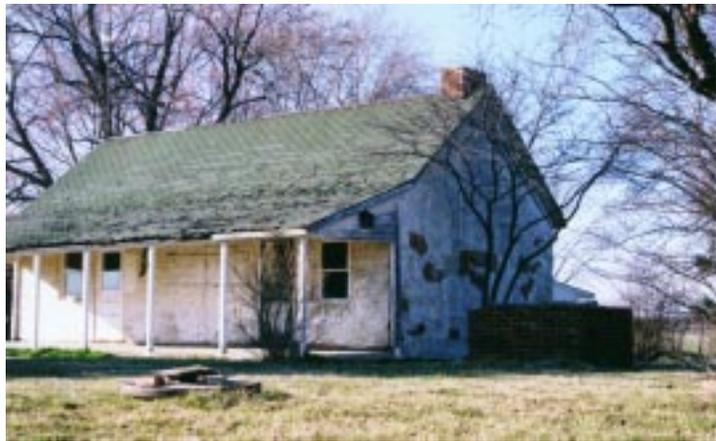
**Fig. 11. Two wells are visible in this image: The current well is in the brick enclosure to the right of the house and an earlier well is in the left foreground.**
